# Manhole Inspection Summary

Manhole # S07II2009MH

Insp Date: **7/6/06 1:31 PM**

**Location** Address: **6305 LINCOLN AVE**

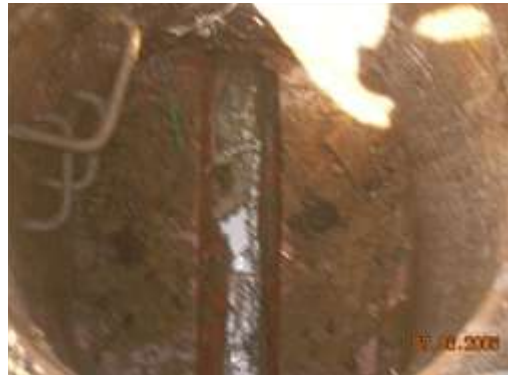
Top View

**Bench** ☒ Exists Material: **Brick** ☐ Parged ☒ **Debris** (not Condition related)

Condition: ☐ Sound ☐ Cracked ☐ Root Intrusion ☒ **Deteriorated** ☐ Leaks ☒ **Debris**

**Surcharge** ☒ **Evidence Of Surcharge** Depth: **1.5** (ft.) ☐ Active Surcharge Present

Evidence of surcharge - Bench debris.  
Channel debris.

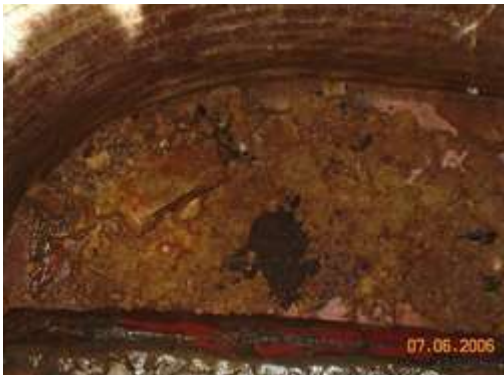
Defect

Bench debris.

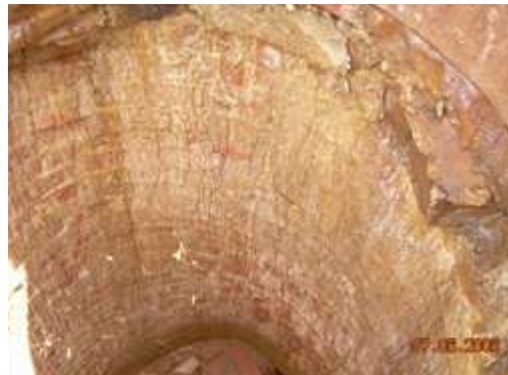
Defect

Condition: ☐ Sound ☐ Cracked ☐ Root Intrusion ☐ Loose Brick ☒ **Deteriorated**

Infiltration: ☐ None ☒ **Joint** ☐ Cracks ☒ **Mortar** ☐ Roots ☐ Wall

Adjustment infiltration detrioation and  
infiltration.

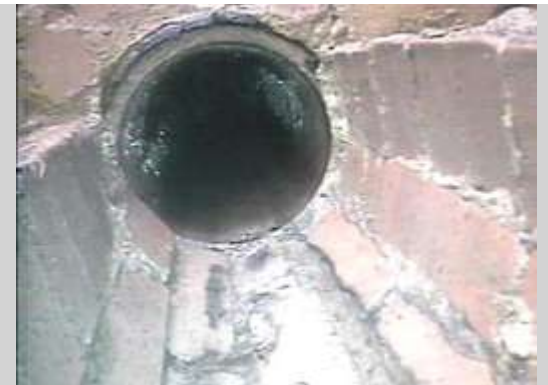
### 8 in. Circular Gravity Sewer Pipe In @ 6 O'Clock

Channel deterioration
